NBSIR 81-2324 (R)

# Boiling Tests of Non-Asbestos-Based Thermal Insulation Used in Air-Conduit Underground Heat Distribution Systems

September 1981

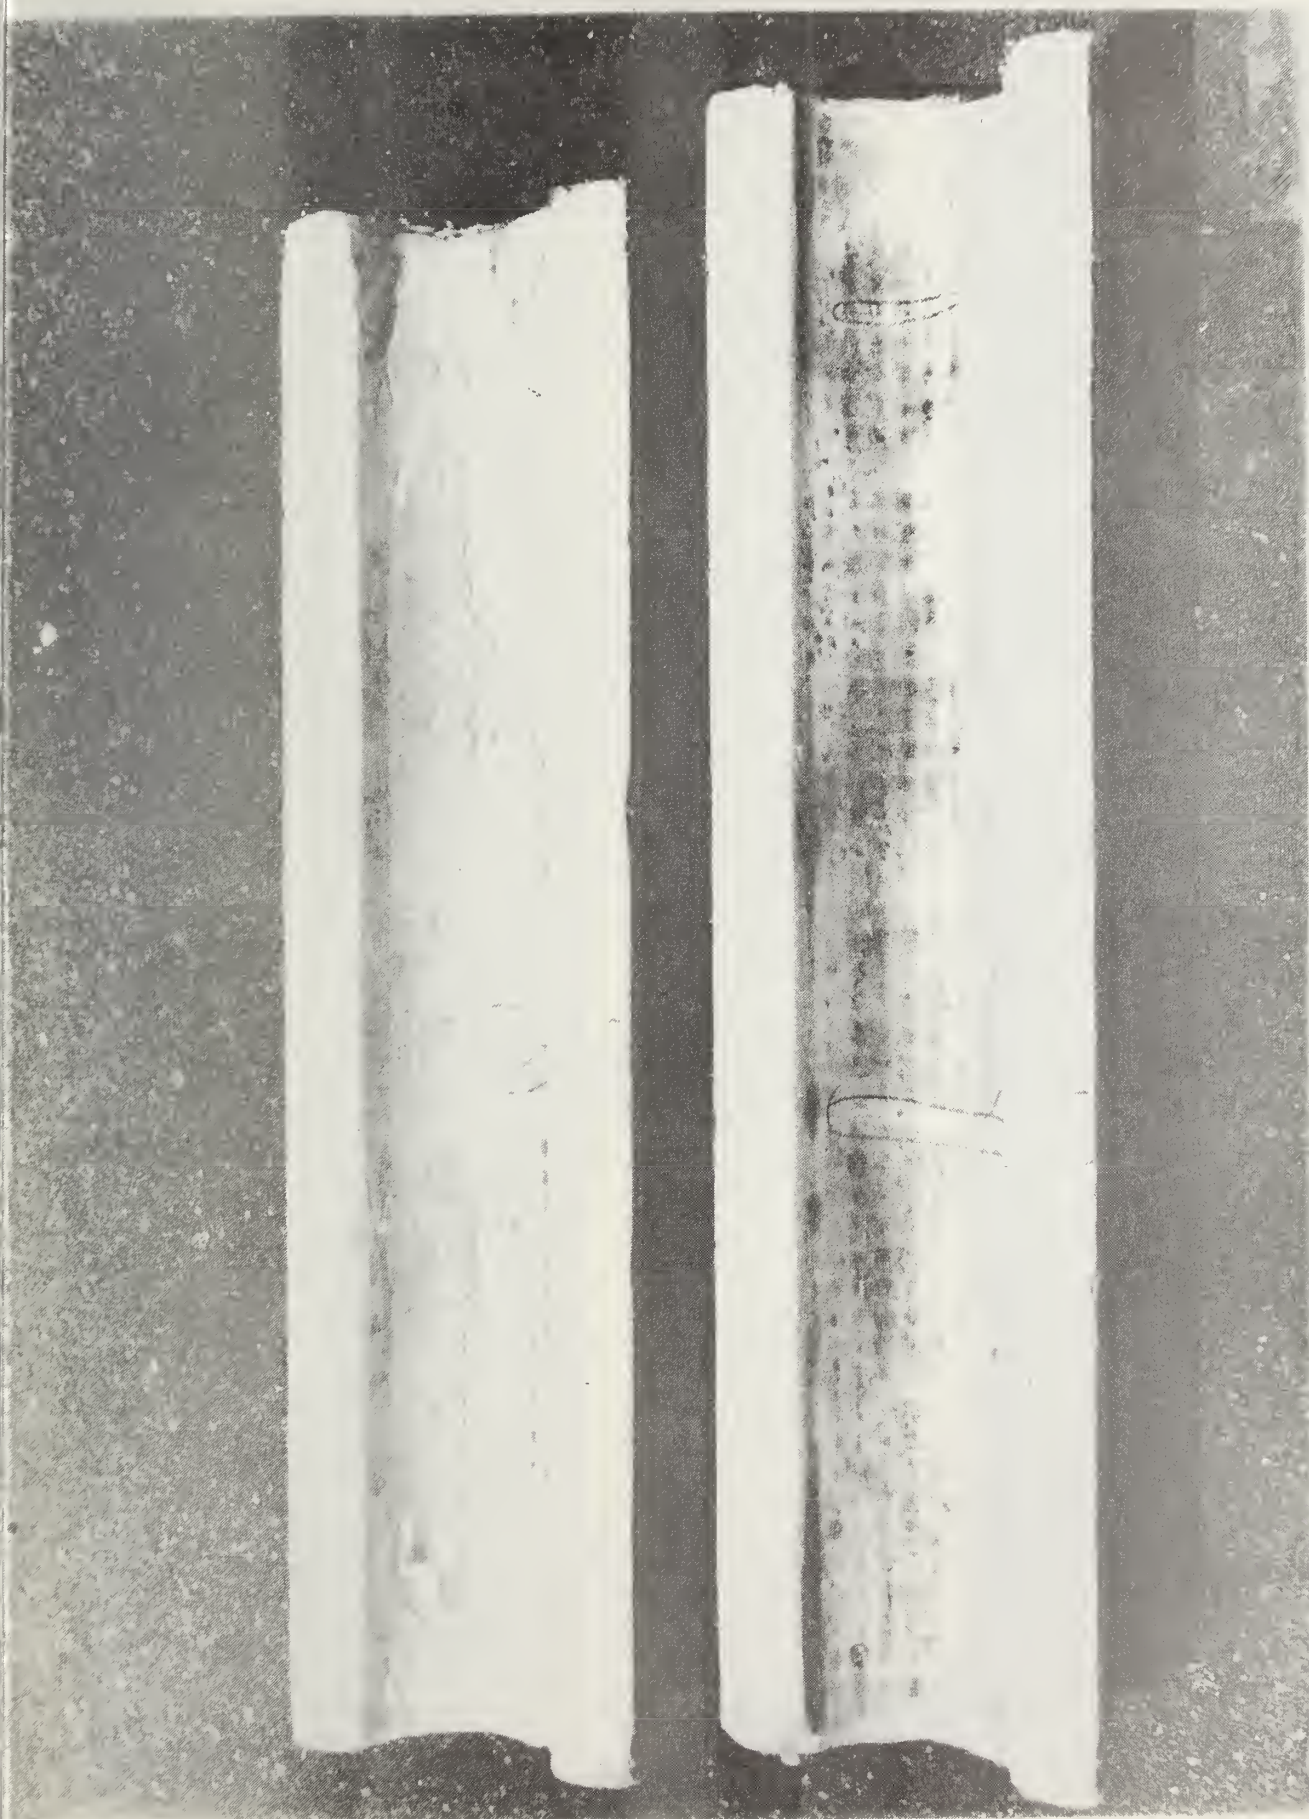
The insulation removed from the conduit after boiling for 192 hours and drying is shown in figure 39. It can be seen at each end of the sections that the insulation scaled and flaked away slightly from the pipe, which would cause the heat loss rate to increase; also in figure 39 are shown cracks in the insulation that indicate that with continued boiling the insulation could break and fall off of the pipe. Figure 40 shows the waterline during boiling, the bands cut into the insulation, and pitting along the water line.

Figure 39. Thermo-12 insulation removed from the conduit after boiling for 192 hours and drying.

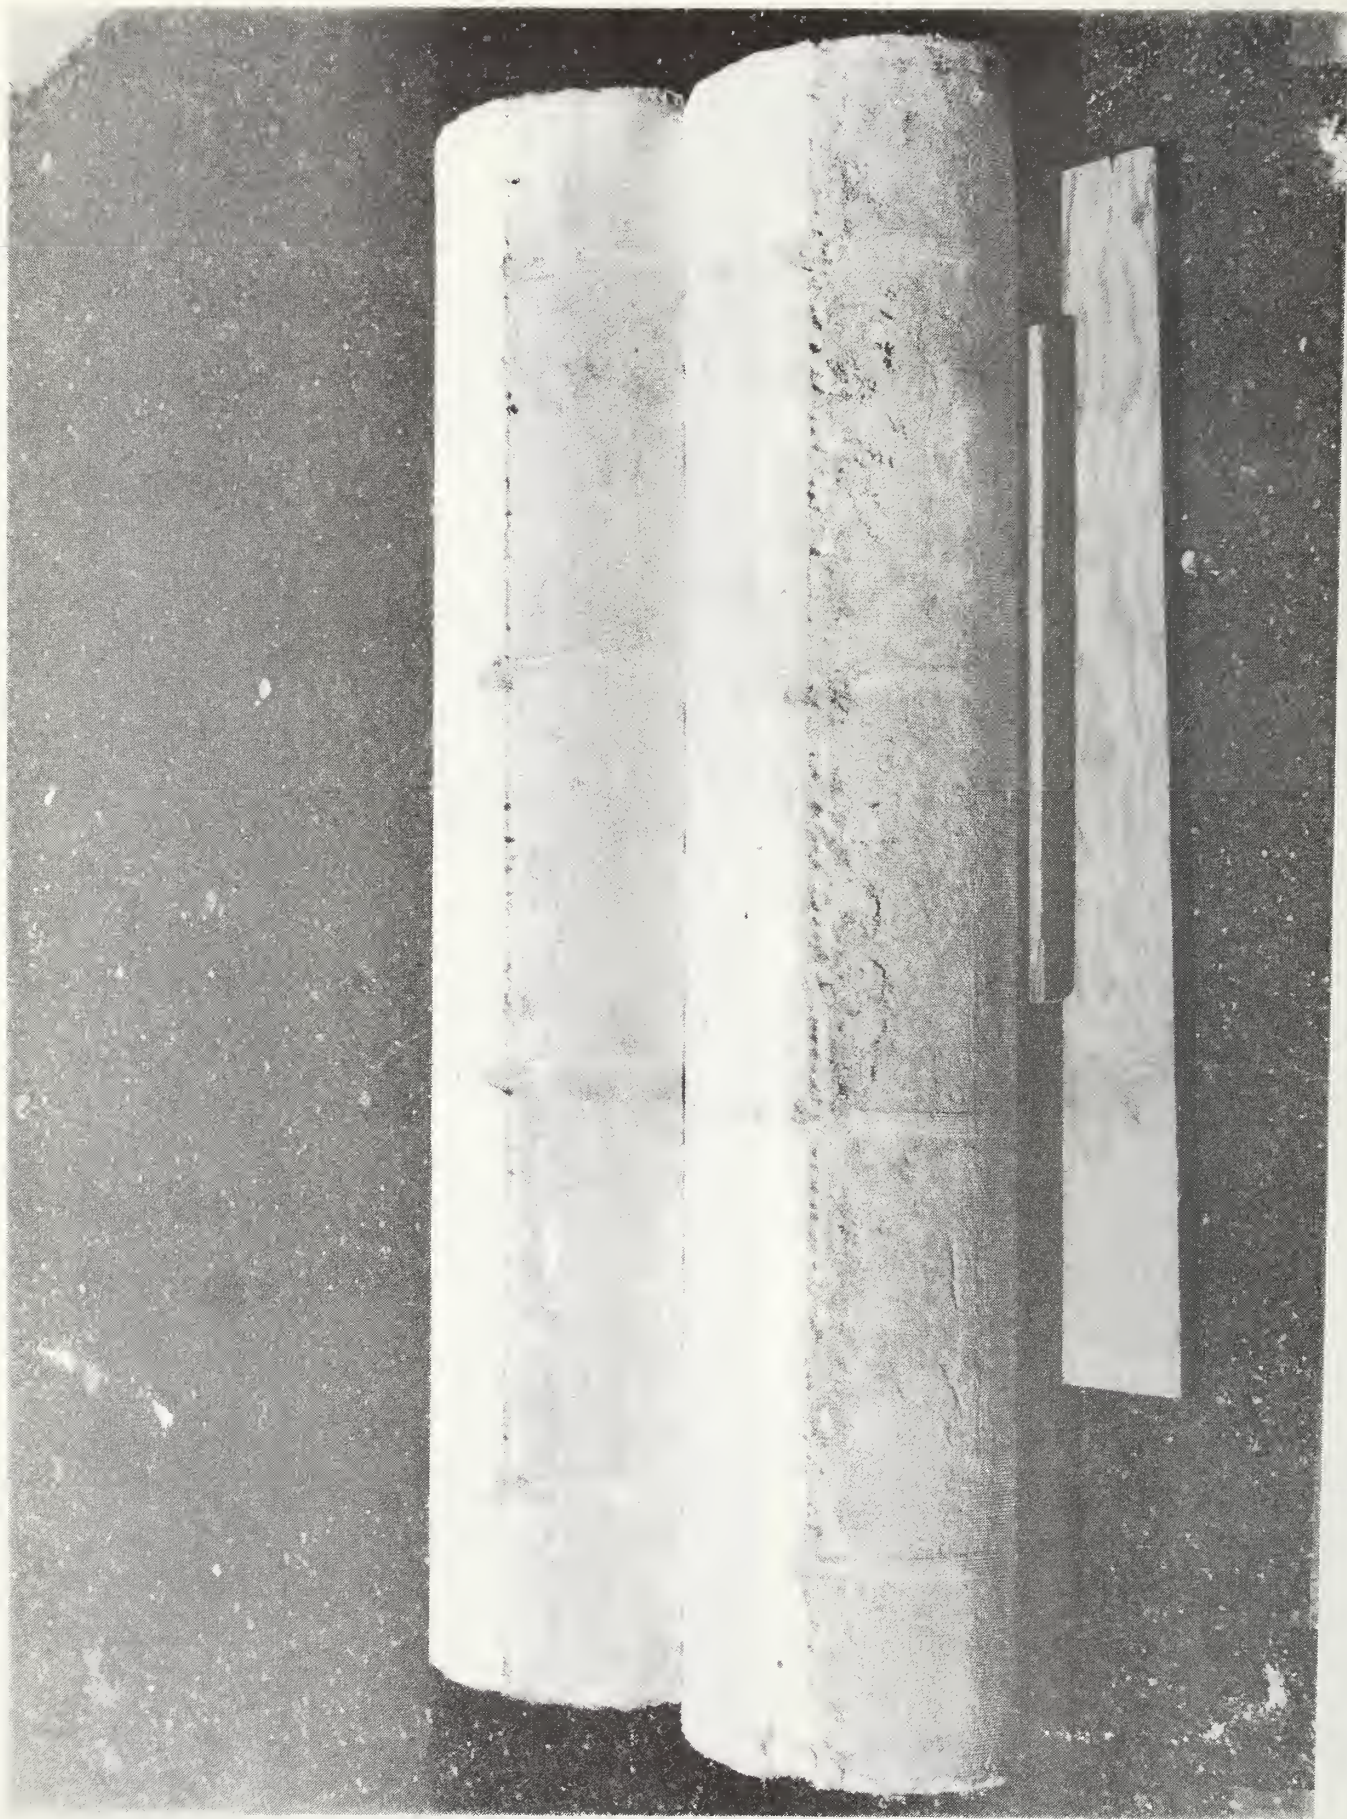
Figure 40. The waterline during the conduit boiling of the Thermo-12 system.

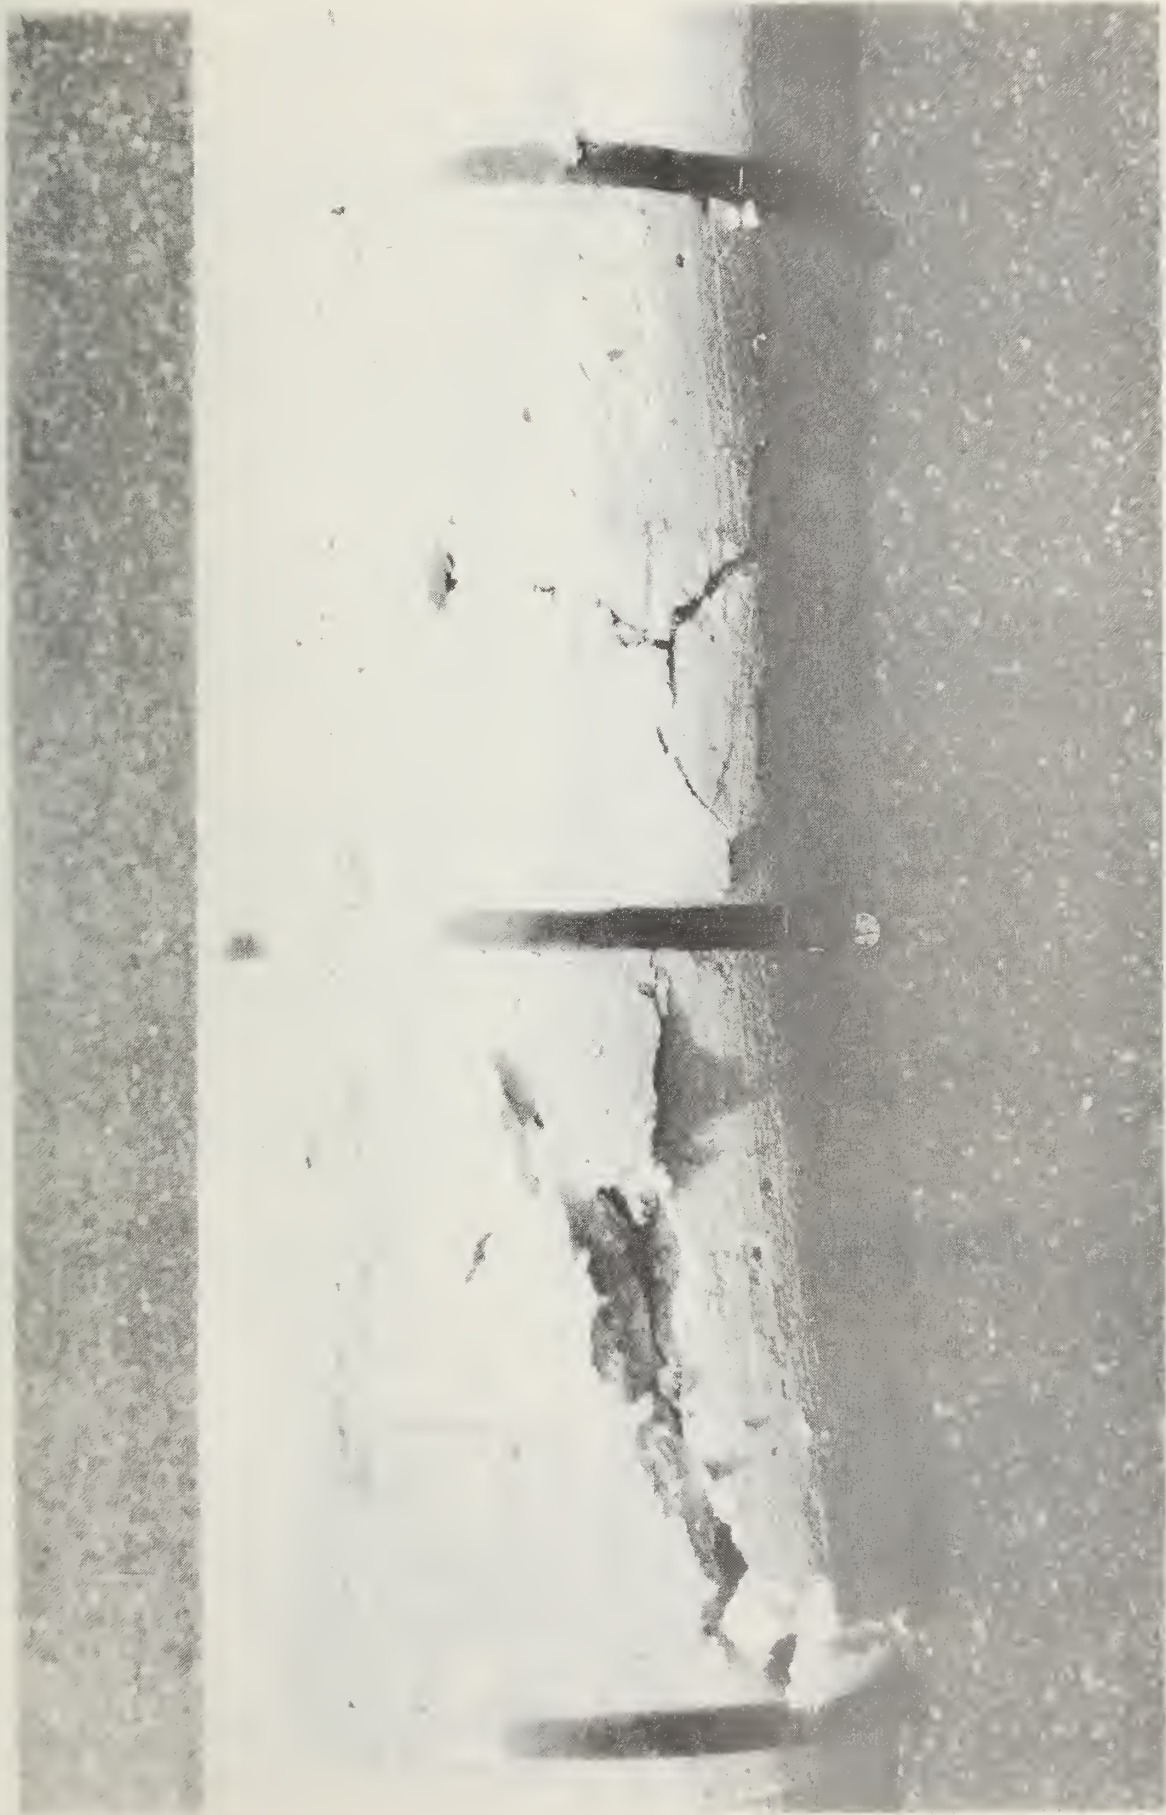
The insulation removed from the conduit after boiling for 192 hours and drying is shown in figure 43. It can be seen that a few portions of insulation were inflated upward against the conduit and cracked. This inflated and cracked condition can be observed on each of five sections along the 20-ft test pipe (figure 44).

Figure 43. The insulation damage due to 192 hours conduit boiling test and subsequent drying (PABCO system).

The pipe heat transfer factor for this particular underground system, therefore, increased less than 10 percent. The system is, however, considered to have failed to meet the TRI-service criteria on account of the physical damage incurred during the boiling.\*

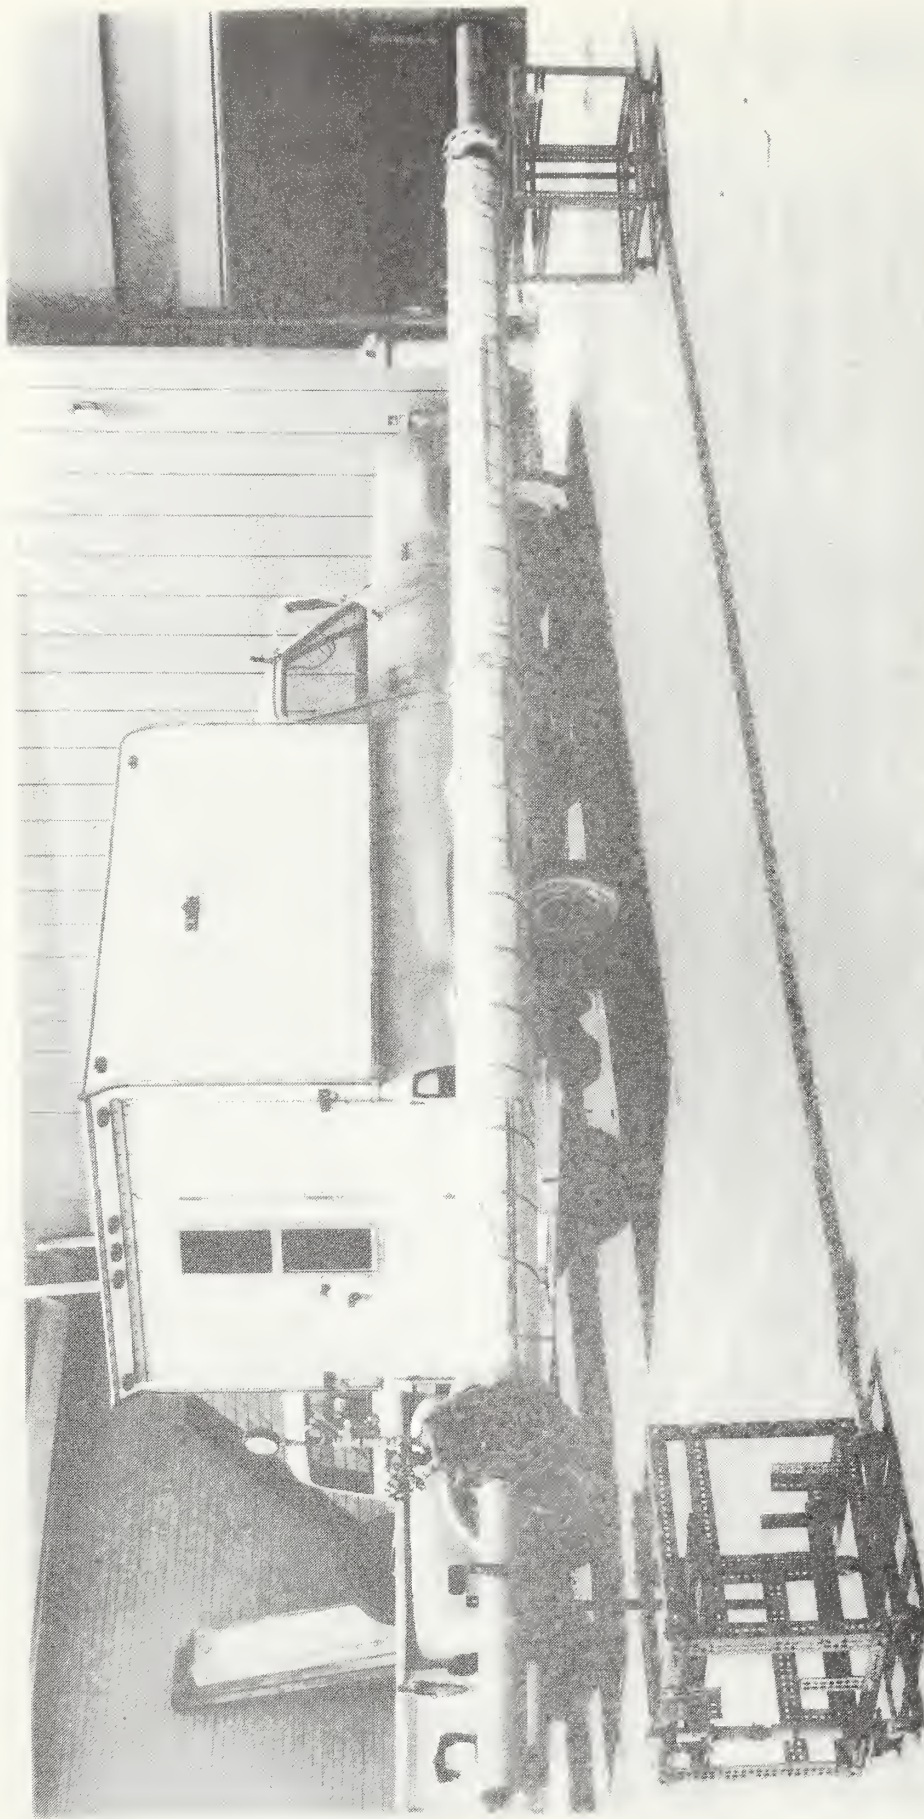
Figure 44. The PABCO thermal insulation system immediately after removal from the conduit where it underwent 192 hours boiling and subsequent drying tests.

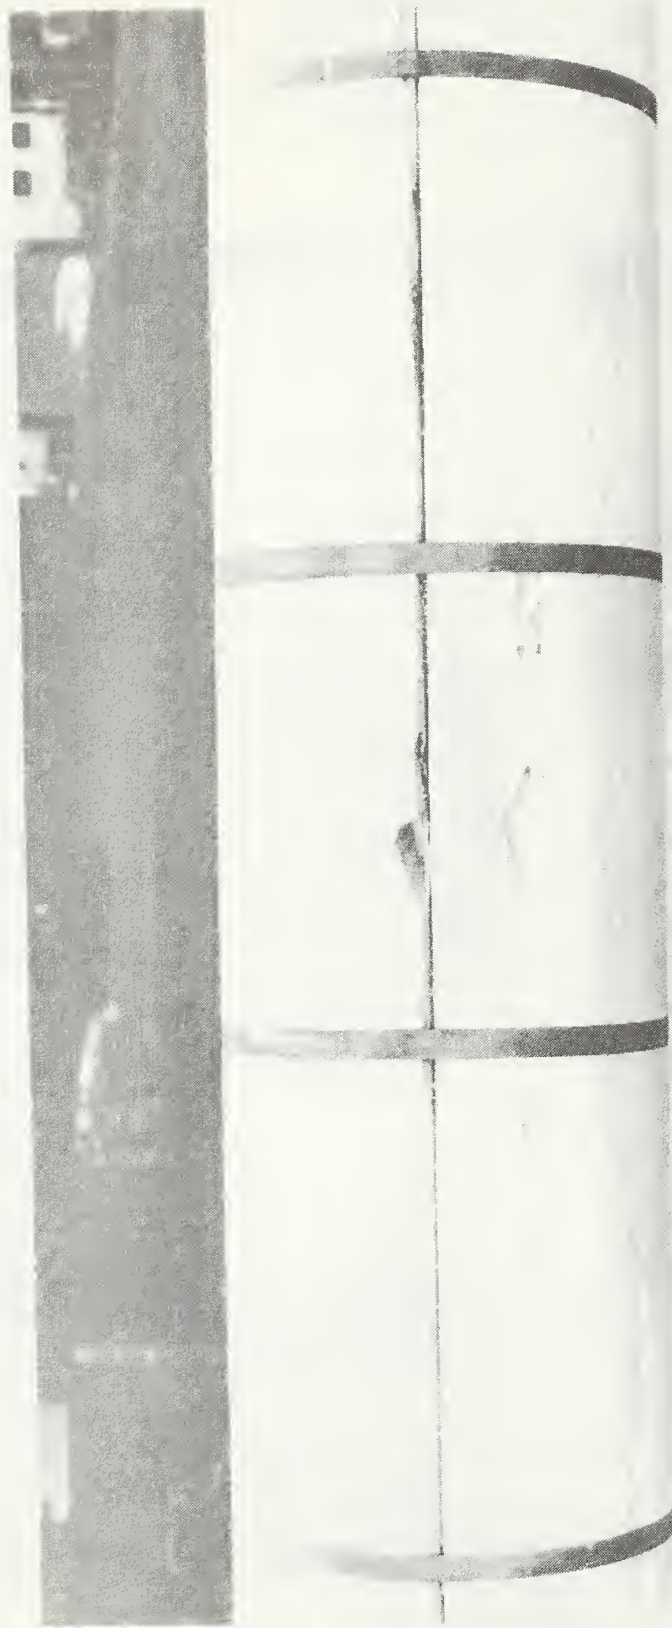
The insulation removed from the conduit after boiling for 96 hours and drying is shown in figure 47. It can be seen at a number of places that the insulation had openings at the joints. Figures 48 and 49 show close-ups of the openings and also the deterioration of the insulation below the water level during boiling. The insulation at the top (above water level) of the pipe was very easy to crumble and could not be taken off the pipe without breaking up (figure 50).

Figure 49. Wesolite after boiling showing deterioration at the bottom of pipe below the water level.

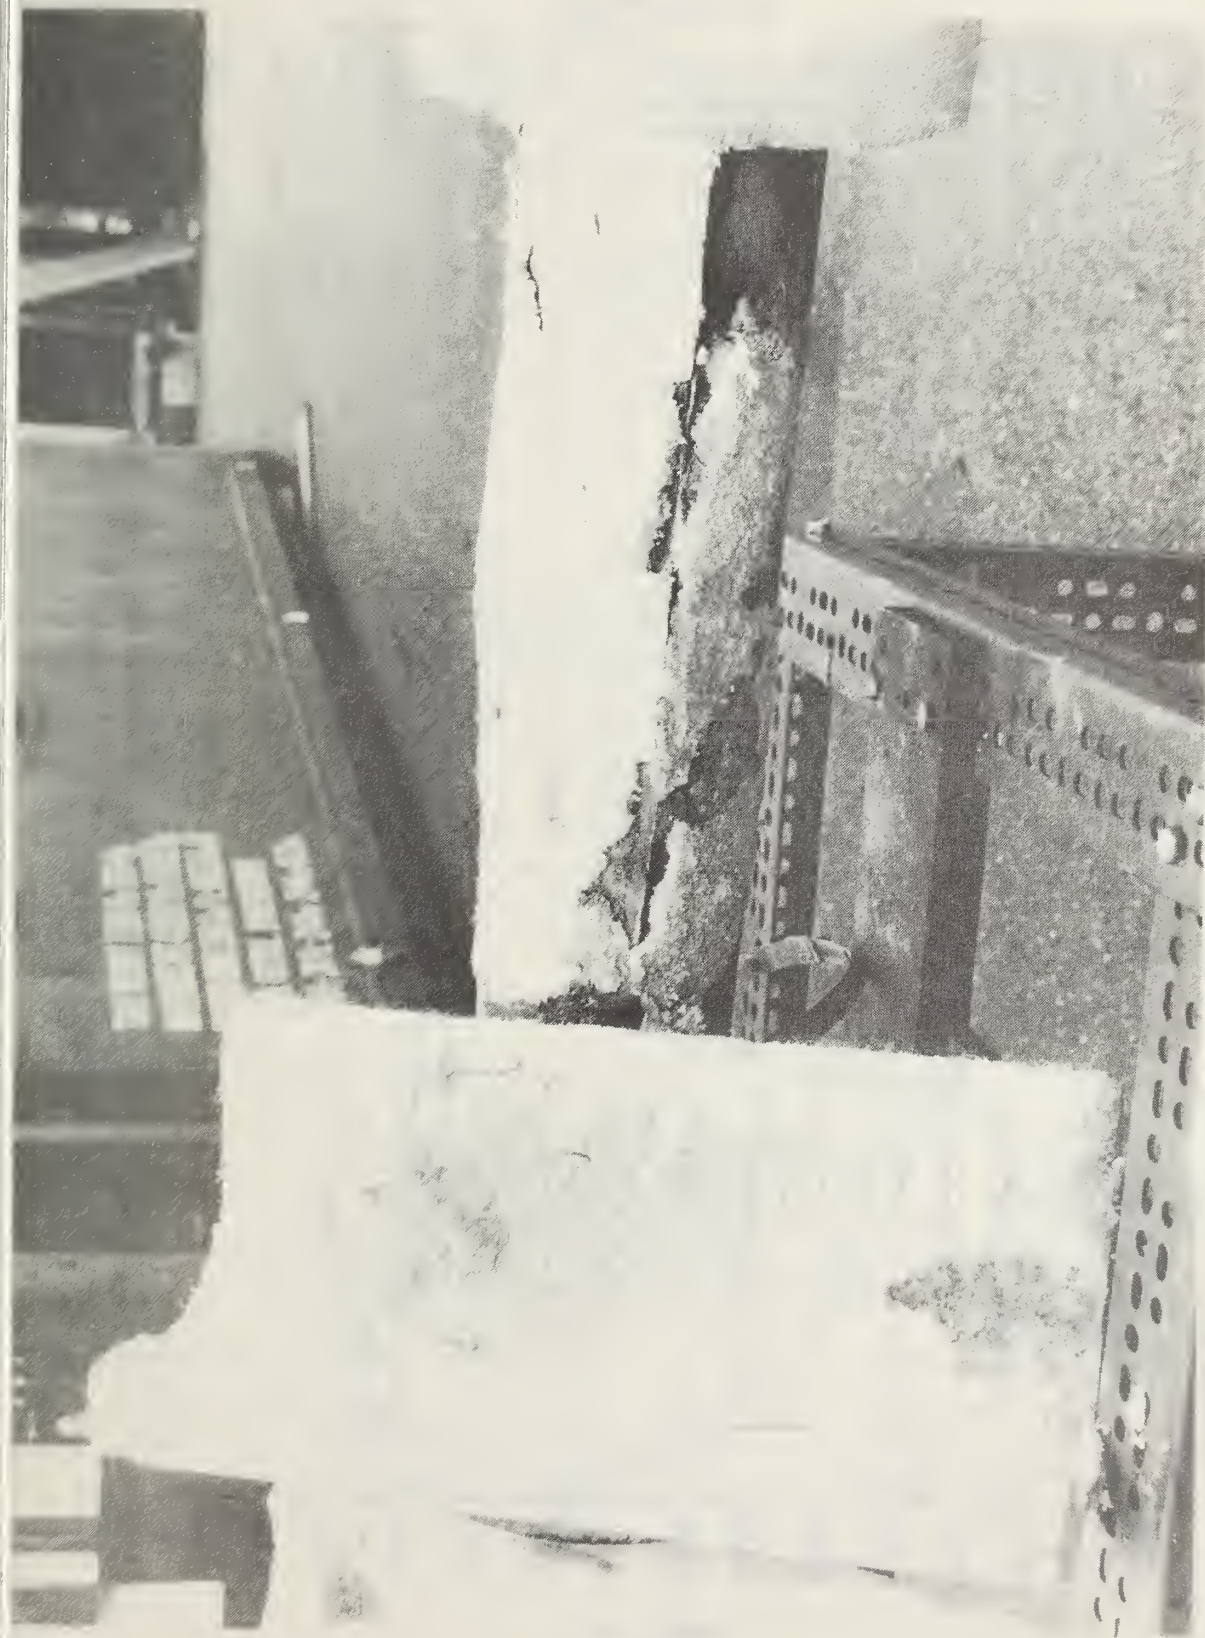
The pipe heat transfer factor for this particular underground system, therefore, increased less than 10 percent. The system is considered to have failed the Tri-service criteria on account of the physical damages incurred during the boiling. A water repellent was added later to help correct the crumbling and loss of hardness in the insulation after this test had been completed.

Figure 50. Condition of Wesolite after removal from pipe after boiling.

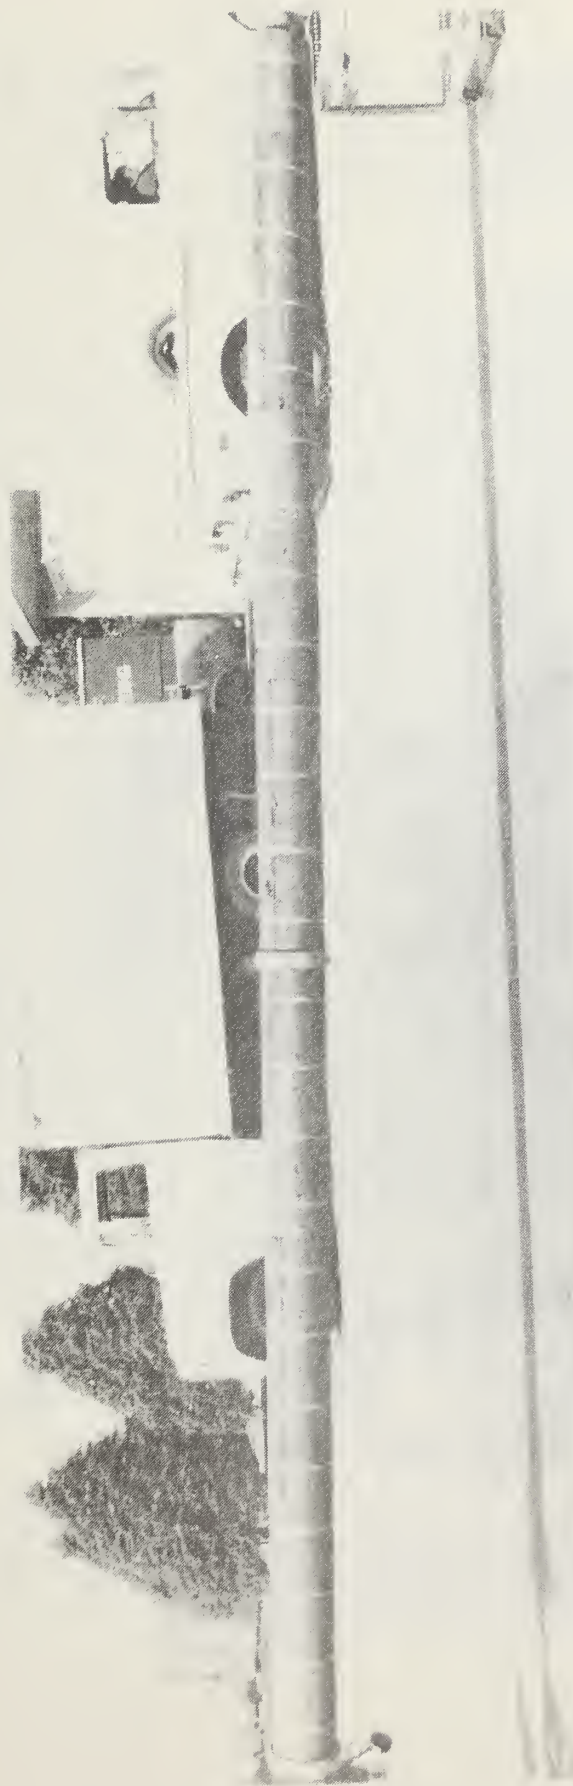
The insulation removed from the conduit after boiling for 96 hours and drying is shown in figure 53. Figure 54 shows close-up of the insulation at the bottom of the pipe (below the water level) after boiling. Figure 55 shows close-up of the insulation at the top of the pipe (above the water level) after boiling.

Figure 53. Epitherm on pipe after removal from conduit after 96 hours of boiling.

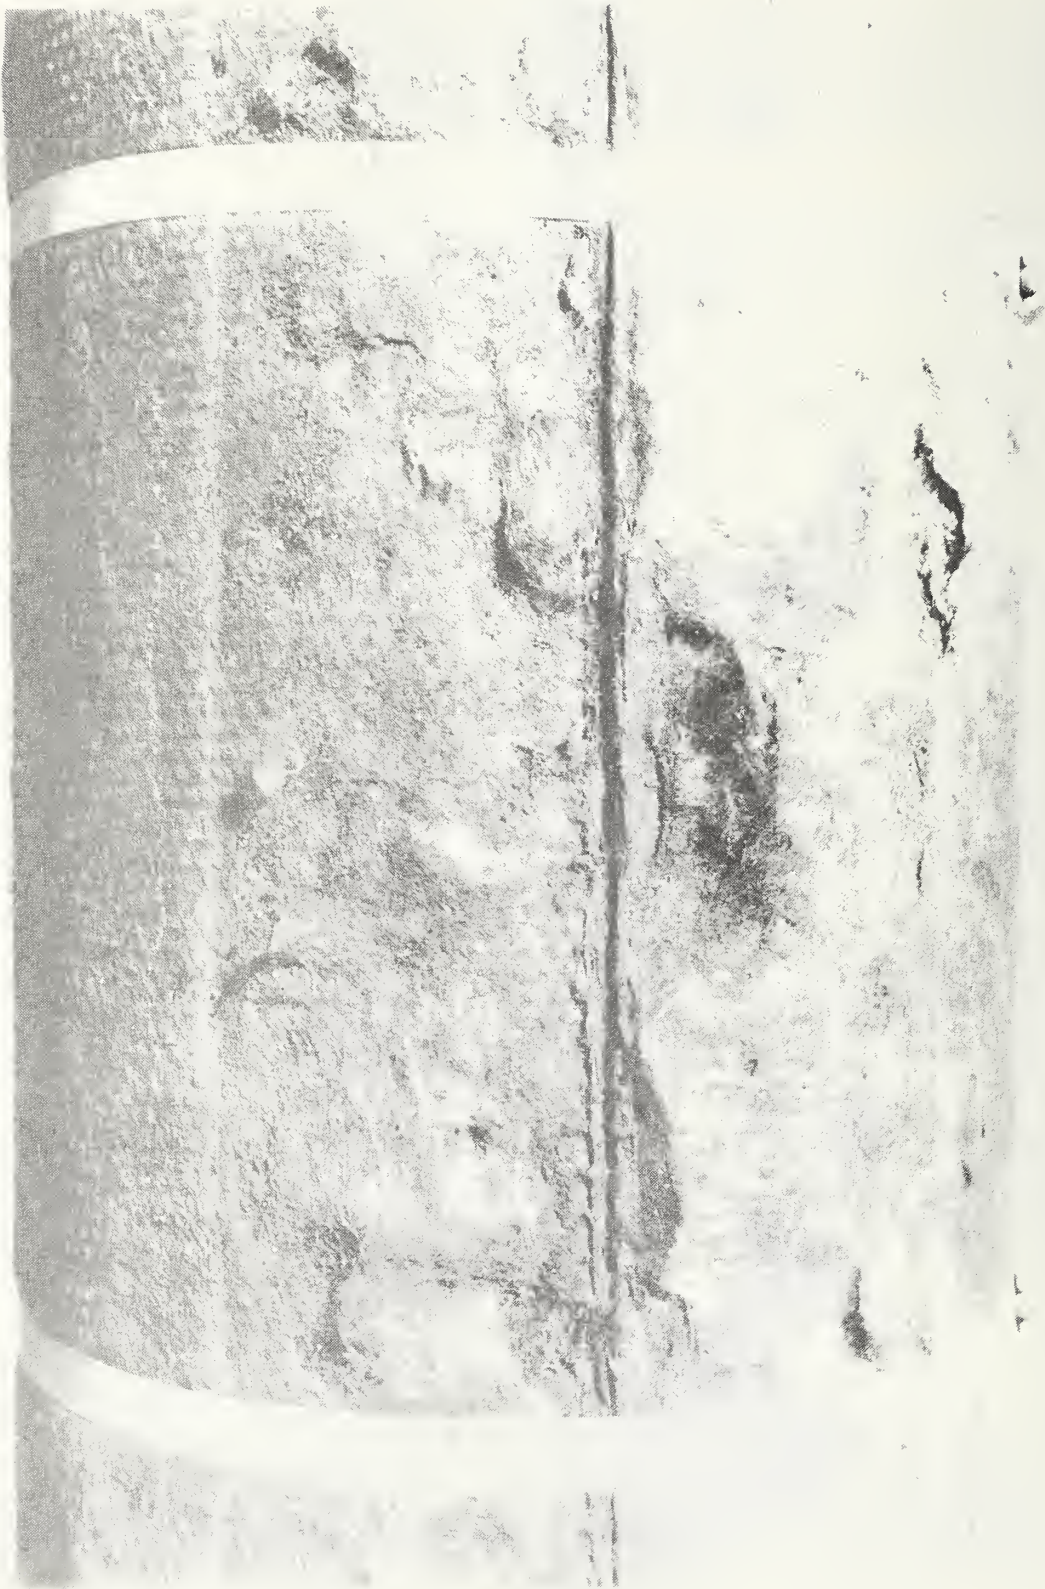
Figure 54. Close-up of Epitherm at the bottom of the pipe after boiling (below the water level).

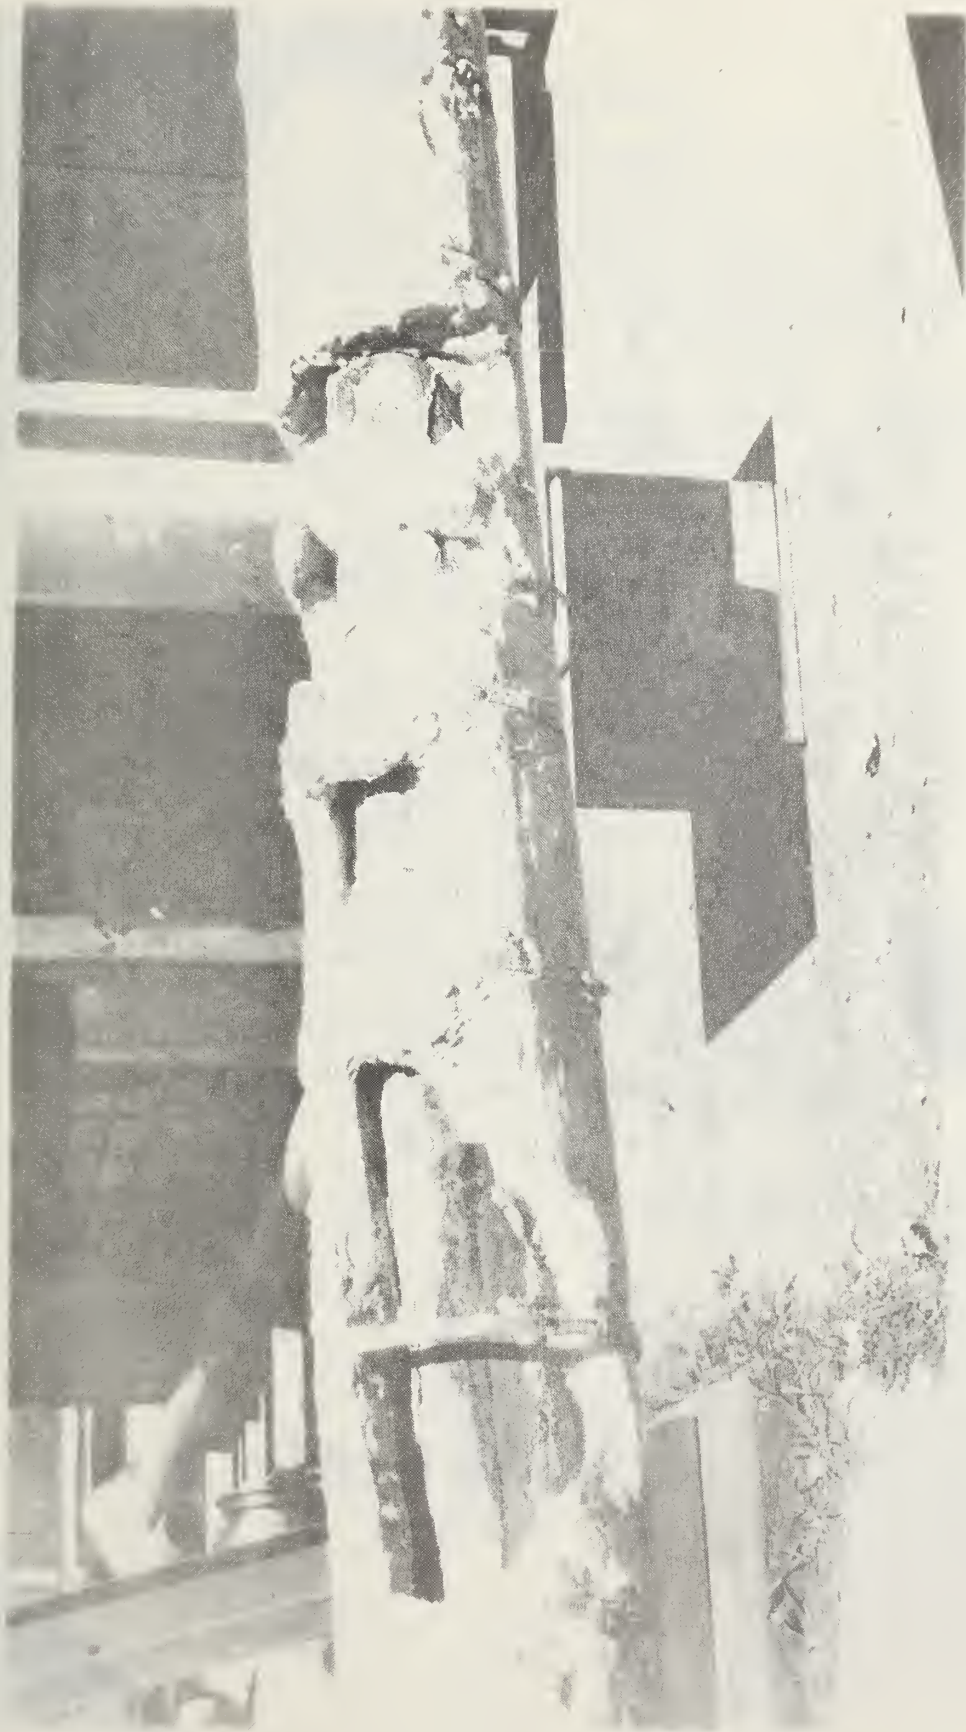
The insulation removed from the conduit after boiling for 96 hours and drying is shown in figure 58. Figure 59 shows close-up of the insulation at the bottom of the pipe (below the water level) after boiling. Figure 60 shows crumbs of insulation found in the conduit space after the carrier pipe and insulation jacket were removed.

The pipe heat transfer factor for this particular underground system, therefore, increased more than 10 percent. The system is considered to have failed the Tri-Service boiling test.

Figure 59. Insulation after boiling showing deterioration at the bottom of the pipe below the water level (Celotemp system).

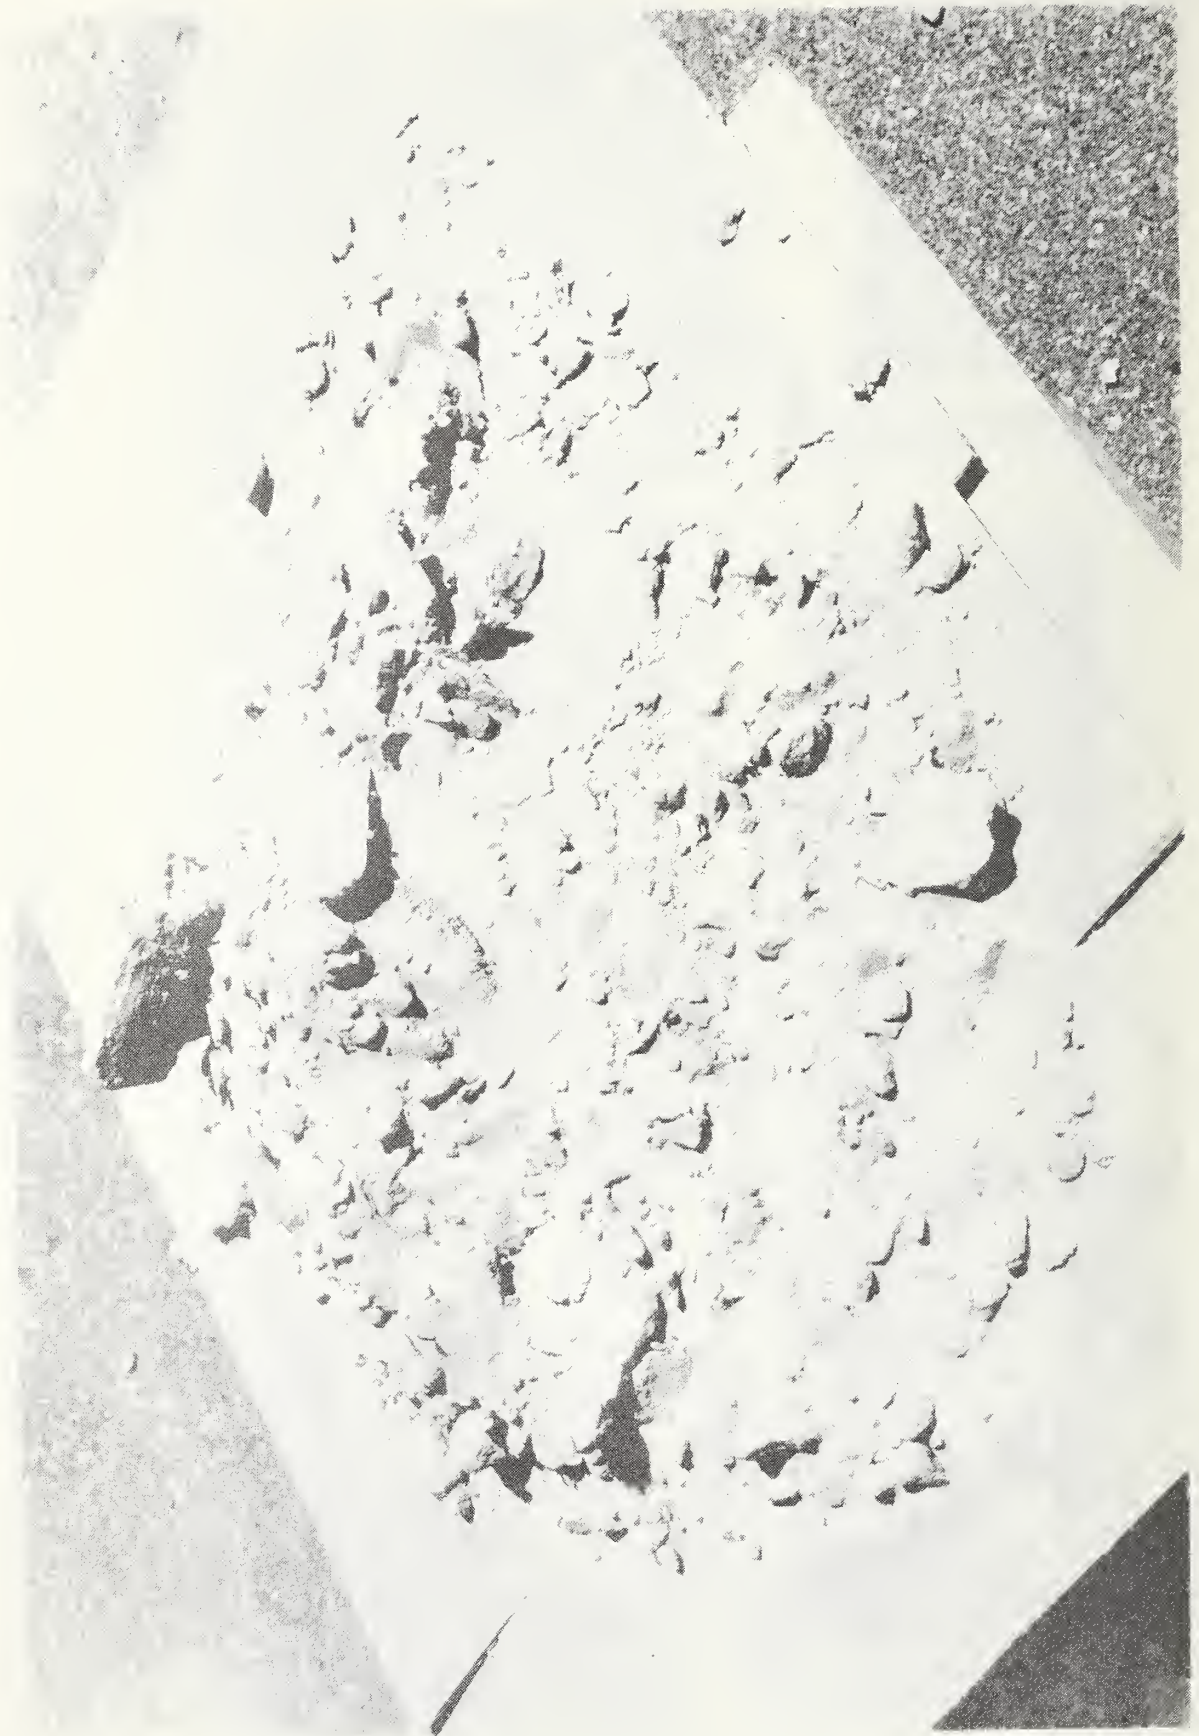
Figure 60. Crumbs of insulation found in the conduit space after the carrier pipe and insulation jacket were removed (Celotemp system).

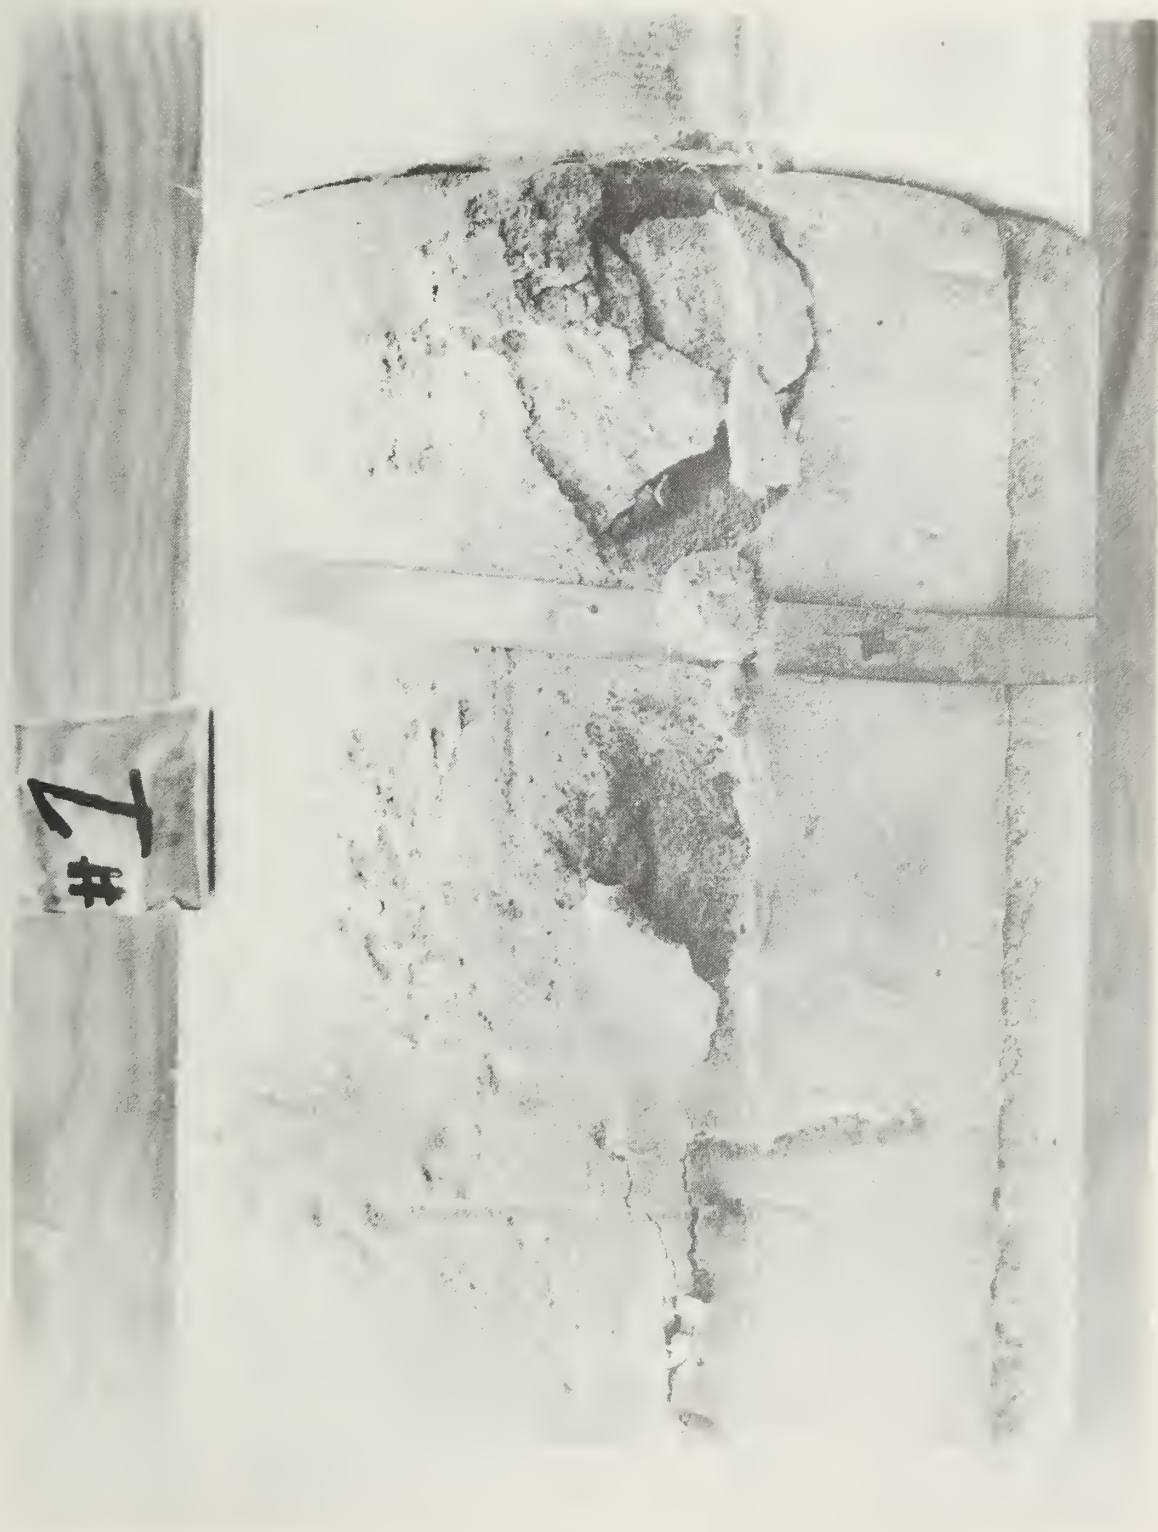
Insulation Material	Days Boiling			
	8	16	24	32
				64
Celotemp 1500 Celotex Corp. Expanded perlite	Started breaking apart Figure 61	Final run insulation 50% off of pipe. Figure 62	---	---
Thermo-12 Johns-Manville Calcium silicate	No physical damage visible to insulation.	Started to show damage. Figure 63	Increased damage apparent. Figure 64	Continuous damage apparent. Figure 65
Epitherm 1200 Eagle-Picher Mineral wool	Slight damage apparent Figure 67	Slightly increased damage. Figure 68	Damage at support on end. Figure 69	Slight increased damage. Figure 70
Wesolite "D" Wesolite Co. Perlite/sodium silicate	Damage below water level. Figure 72	Joint opening slightly Figure 73	Slight damage at joint. Figure 74	Damage at end of section. Figure 75
Super Caltemp Pabco Calcium silicate	No physical damage visible to insulation.	Cracks visible in insulation. Figure 77	No increase in damage visible. Figure 78	Damage below water level. Figure 79

Figure 61. Celotemp 1500 after 8 days boiling.
